Memo: TLR951x Errata

From: Telink Semiconductor

1. Introduction

This document presents Errata information for the TLR951x chip A0 and A1 version engineering sample (ES). This document applies to the chip with marking shown below.

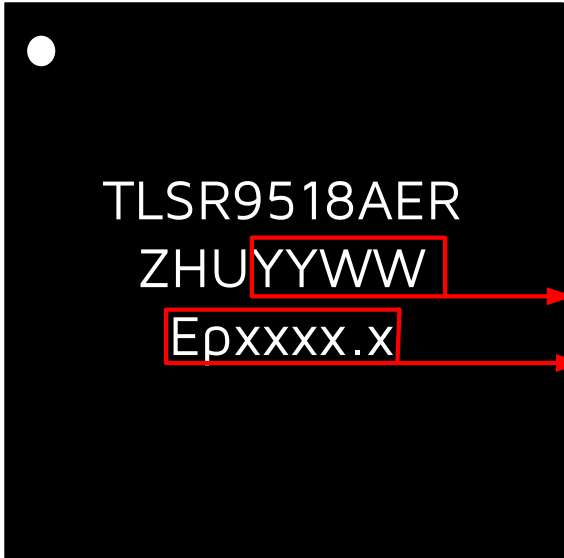
The SoC is marked as following (take TLR9518 as an example),

YYWW-Date code:
Year + week

Lot No.
