Telink

Memo: TLSR951x Errata

This document presents Errata information for the TLSR951x chip A1 version engineering sample (ES) and A2 version mass production (MP). This document applies to the chip with marking shown below.

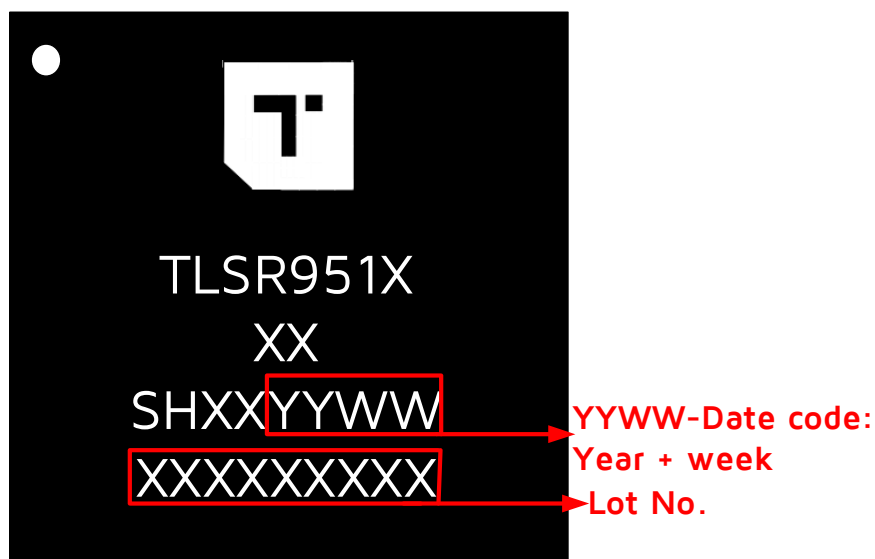
The SoC is marked as following (take TLSR9518 as an example),

Product Series	Lot. No.	Version ID
TLSR951x A1 Version	EP9044.12& EP9044.13	0xFE
TLSR951x A2 Version	EP9327.14	0xFA

Note: Version ID can be read from register 0x140e02[1:0].
